# **INDOOR AIR QUALITY ASSESSMENT**

**Julia Bancroft Elementary School  
3 Vinal Street  
Auburn, Massachusetts**

Prepared by:  
Massachusetts Department of Public Health  
Center for Environmental Health  
Bureau of Environmental Health Assessment  
Emergency Response Indoor Air Quality Program  
May 2004

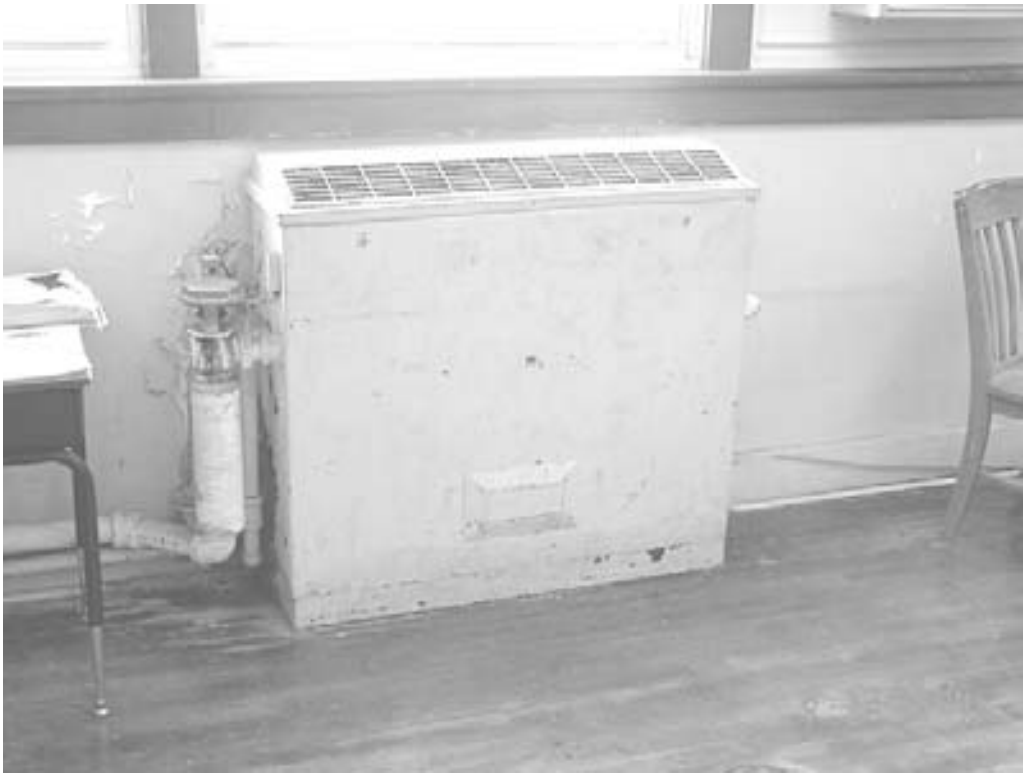
**Picture 1**

Fresh air in classrooms of these sections of the building was originally supplied by a unit ventilator (univent) system (Picture 1). Univents are designed to draw air from outdoors through a fresh air intake located on the exterior walls of the building (Picture 2) and return air through an air intake located at the base of each unit ([Figure 1](#)). Fresh and return air are mixed, filtered, heated and provided to classrooms through a fresh air diffuser located in the top of the unit. Univents appear to be original equipment, approximately 80 years old. Function of such aged equipment is difficult to maintain, since compatible replacement parts are often unavailable. Due to the age of the equipment, univents were not operating at the time of the assessment. As a result, no mechanical means for providing fresh air to classrooms exists.

**Classroom Univent**

1. Consider consulting a heating, ventilation and air conditioning (HVAC) engineer concerning the operability of univents.
2. Discontinue use of kiln until local exhaust ventilation can be provided. Local exhaust should be ducted directly to the outdoors.

1. Based on the age, physical deterioration and availability of parts for ventilation components, the BEHA strongly recommends that an HVAC engineering firm fully evaluate the ventilation systems throughout the building.
2. Examine the feasibility of repair vs. replacement of univents. Determine if existing vents, ductwork, etc. can be retrofitted for (modern) mechanical ventilation.
3. Examine the feasibility of providing mechanical ventilation to the speech room and the library.
4. Evaluate thermostat settings throughout the school. Thermostats should be set at temperatures to maintain comfort for building occupants.
5. Replace/repair window systems throughout the building -wide to prevent water penetration and drafts through window frames.

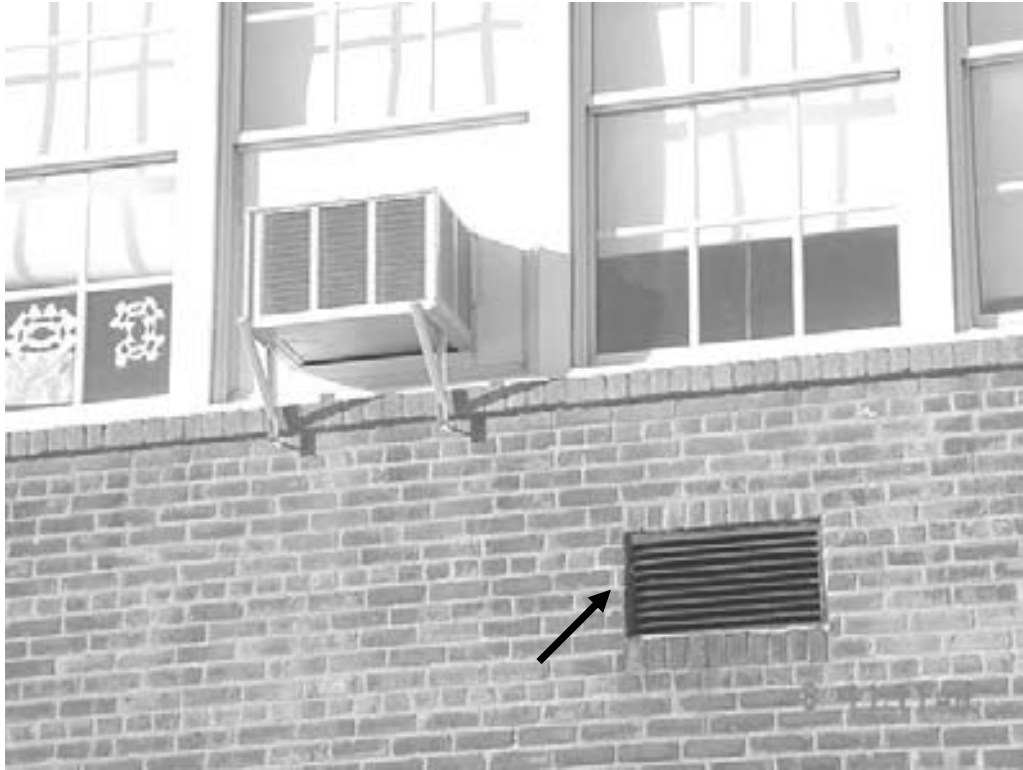
**Picture 2**

**Univent Fresh Air Intake**

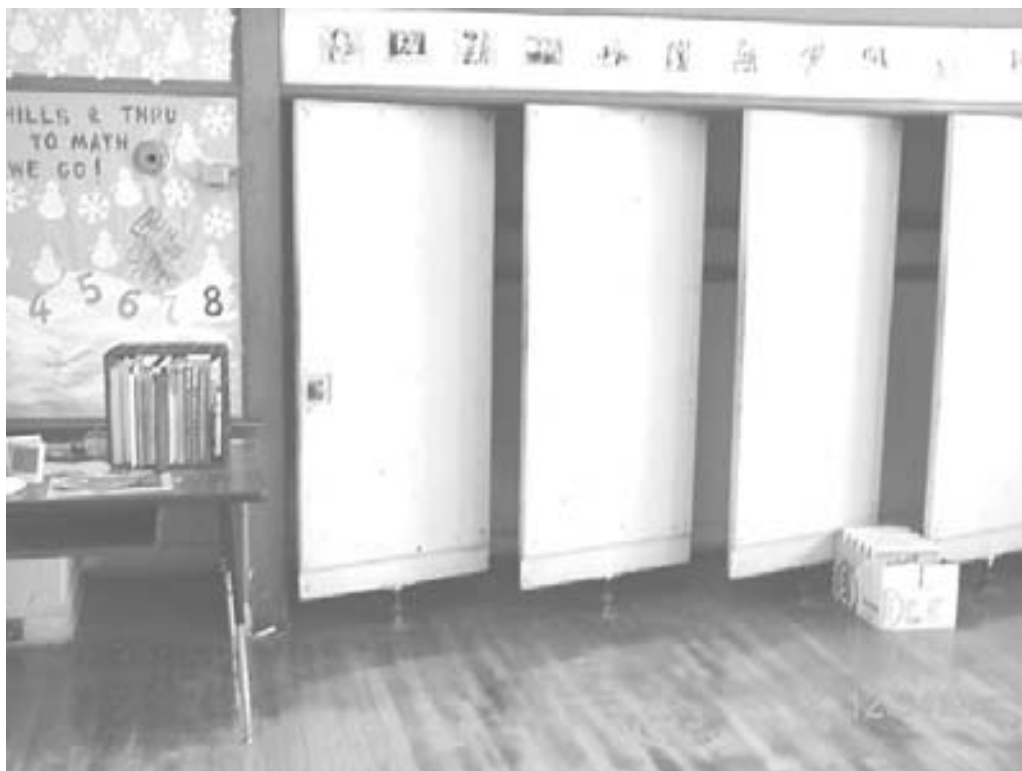
**Picxture 3**

Exhaust vents in the original building are located in coat closets (Pictures 3 and 4) or in ungrated “cubby holes” located at floor level in classrooms (Picture 5). Classroom air is drawn into the coat closet via an undercut below the closet door. Both these exhaust designs allow for the vents to be easily blocked by stored materials (Pictures 4 and 5). In order to function properly, these vents must remain free of obstructions.

**Undercut Coat Closets in Classroom**

4. Remove all blockages from exhaust vents to ensure adequate airflow.
5. Operate all ventilation systems that are operable throughout the building (e.g., gym, auditorium, classrooms) continuously during periods of school occupancy independent of thermostat control to maximize air exchange.

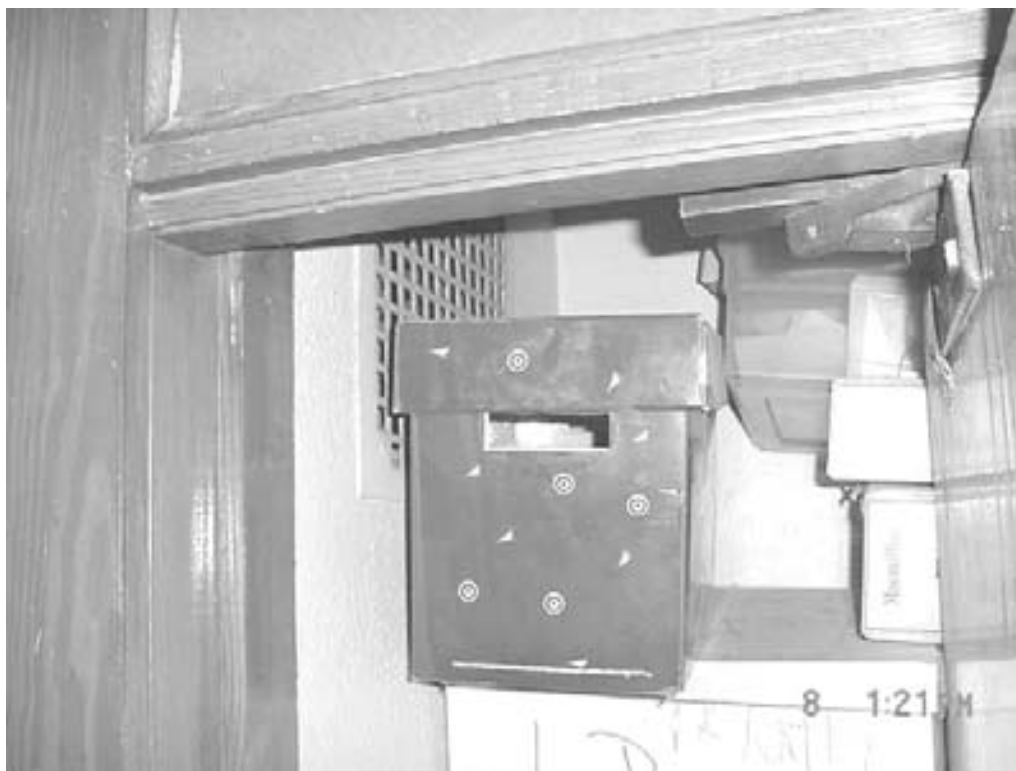
**Picture 4**

**Coat Closet Exhaust Vent Obstructed by Box**

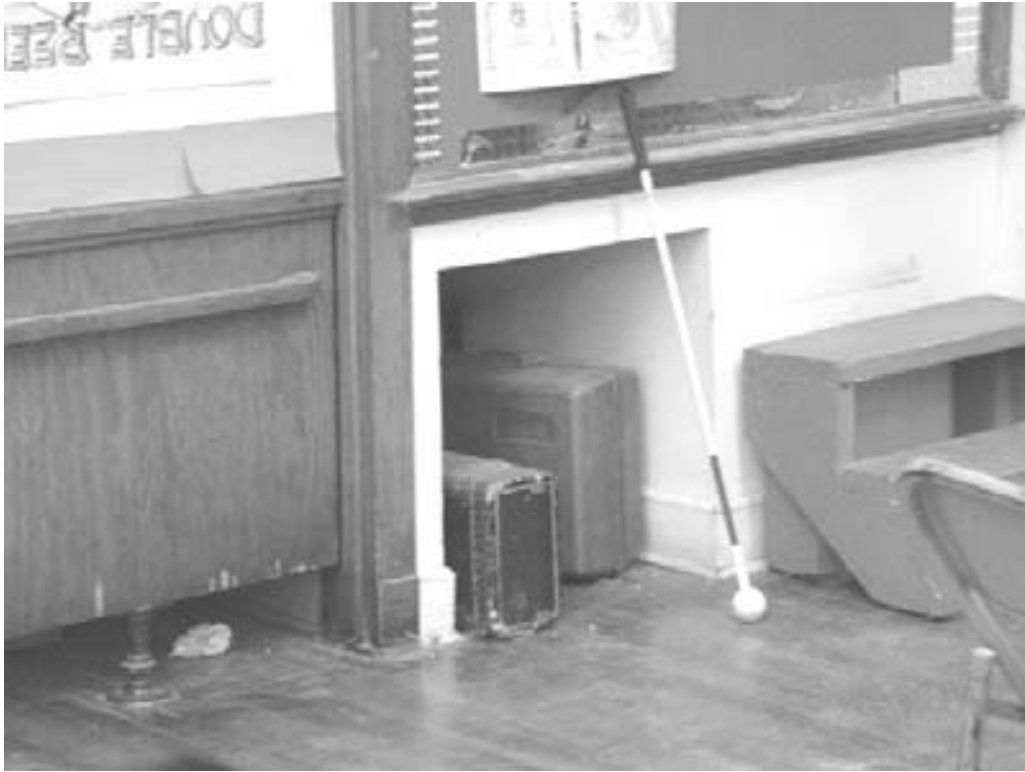
**Picture 5**

**Exhaust Cubby Used for Storage**

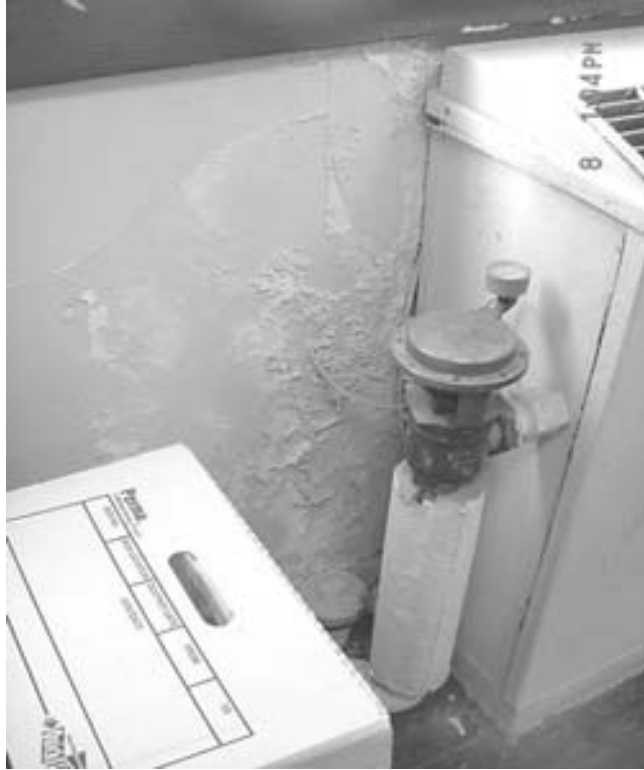
**Picture 7**

Efflorescence was observed on the walls of classrooms near univents (Picture 7). Efflorescence is a characteristic sign of water damage to building materials such as brick or plaster, but it is not mold growth. As moisture penetrates and works its way through mortar around brick, water-soluble compounds dissolve, creating a solution. As the solution moves to the surface of the brick or mortar, water evaporates, leaving behind white, powdery mineral deposits. This condition indicates that water from the exterior has penetrated into the building.

**Efflorescence on Wall in Classroom**

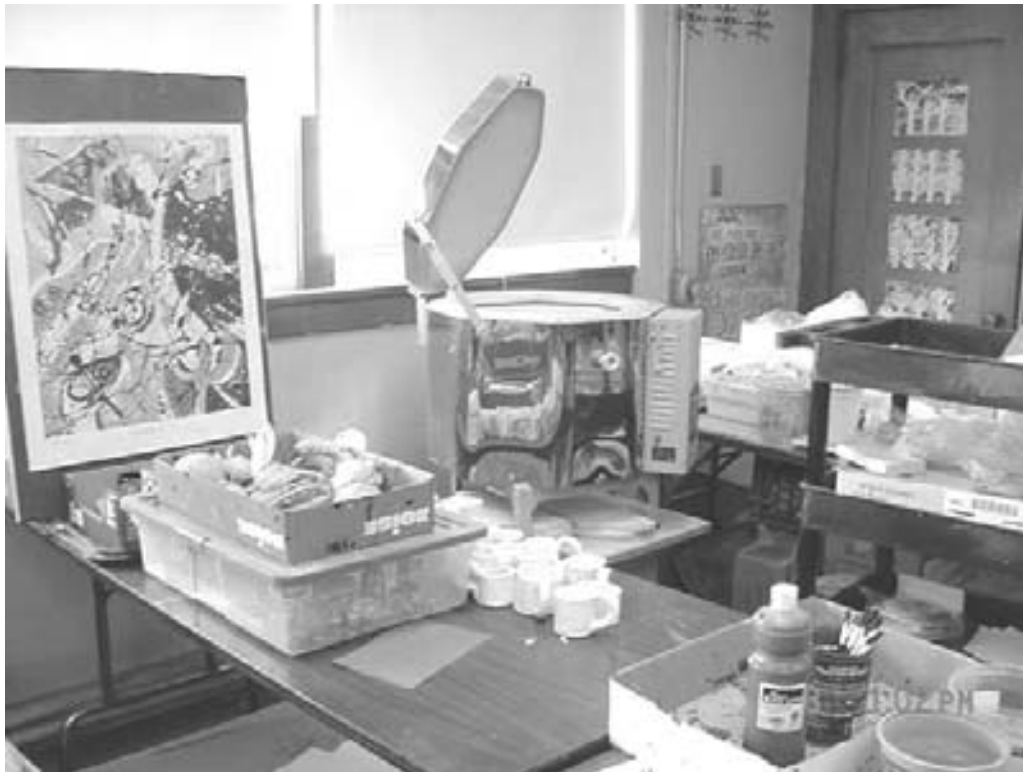
**Picture 8**

The art room contained an unvented kiln (Picture 8). Kiln exhaust may produce corrosive, hazardous and irritating materials including chlorine, sulfur dioxide and carbon

monoxide. Pottery kilns should be provided with dedicated local exhaust ventilation (McCann, 1985) to ventilate these possible emissions from the interior of the building.

**Unvented Kiln in Artroom**

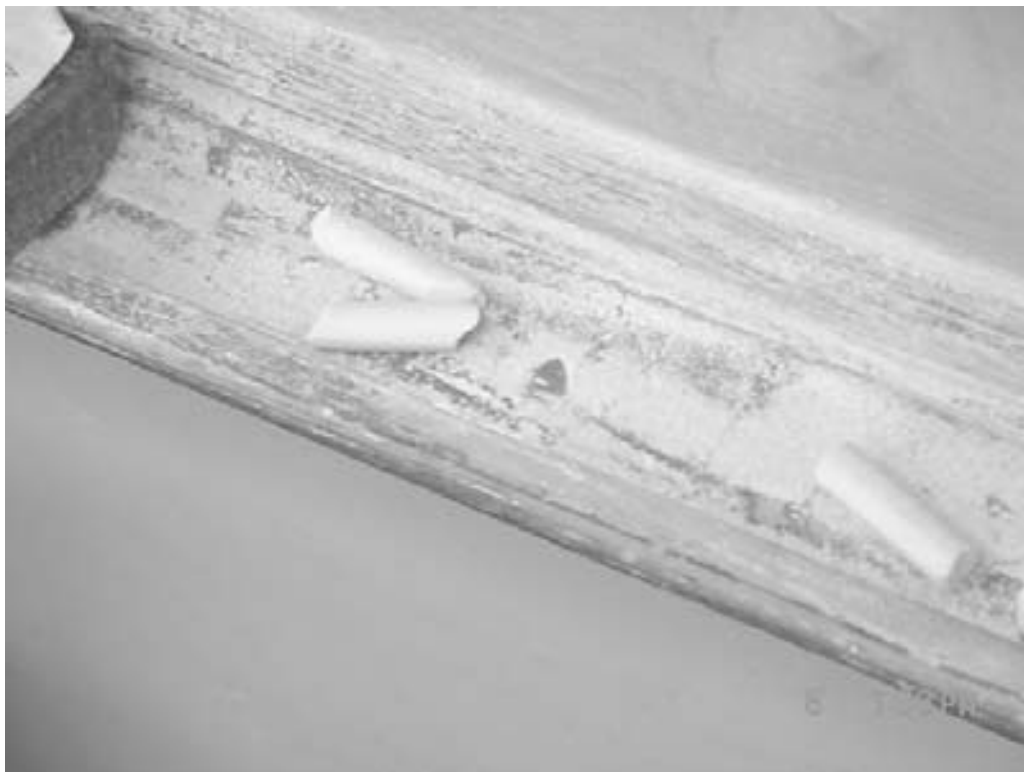
**Picture 9**

Accumulated chalk dust (Picture 9) and dry erase markers were seen in several classrooms. Chalk dust is a fine particulate, which can become easily aerosolized and serve as a source of eye and respiratory irritation. Materials such as dry erase markers and dry erase board cleaners may contain VOCs, (e.g. methyl isobutyl ketone, n-butyl acetate and butyl-cellusolve) (Sanford, 1999).

**Accumulated Chalk Dust in Classroom**

11. Encapsulate exposed pipe insulation to avoid the aerosolization of fiberglass fibers.
12. Clean chalkboard/dry erase marker trays regularly to prevent the build-up of excessive chalk dust and particulate.

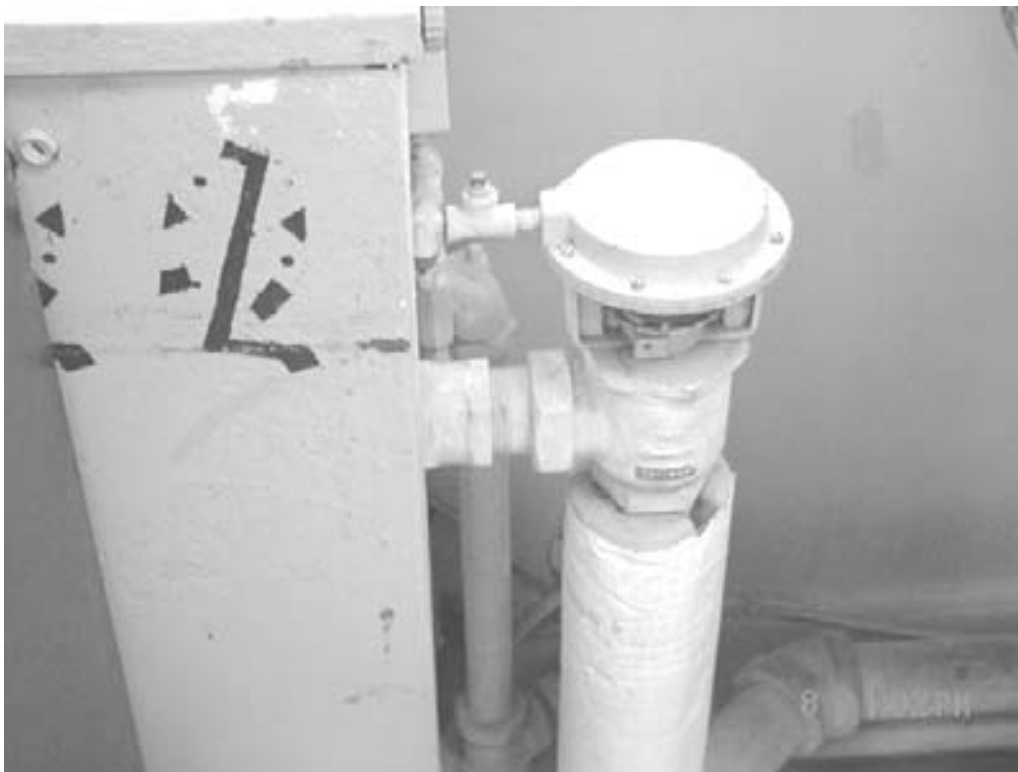
**Picture 10**

Several other conditions that can affect indoor air quality were noted during the assessment. Exposed fiberglass insulation was noted around pipes in classrooms (Picture 10). Fiberglass insulation can be a source of skin, eye and respiratory irritation to sensitive individuals.

**Exposed Fiberglass Insulation around Pipes in Classroom**

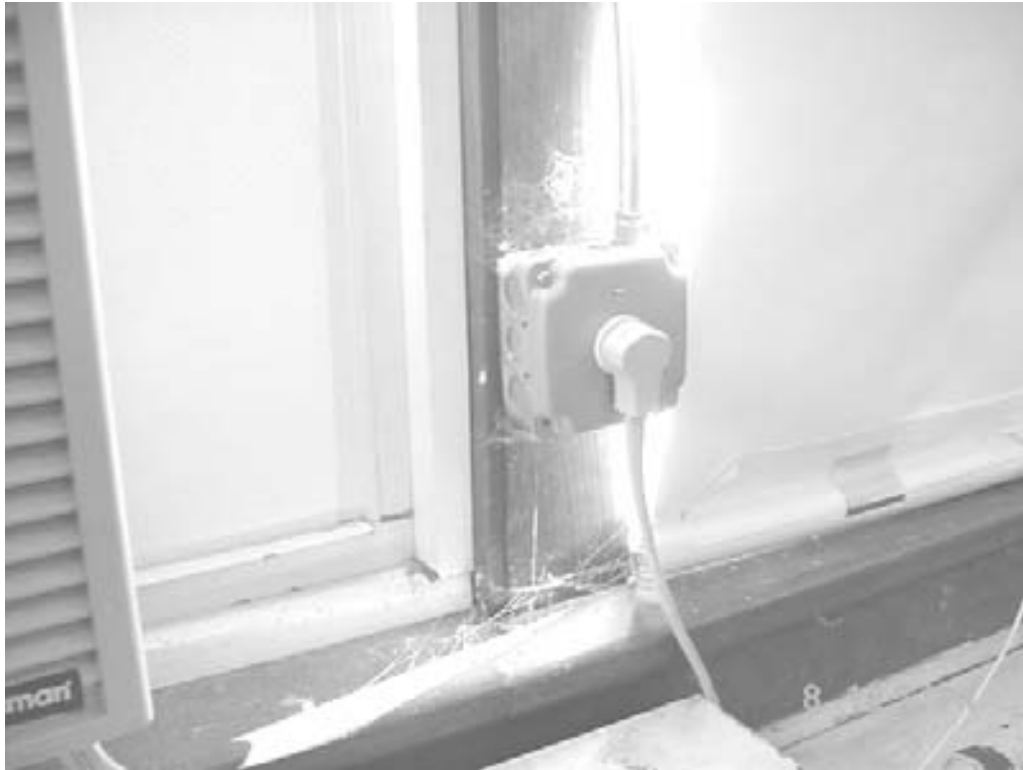
**Picture 11**

Also of note was the amount of materials stored inside classrooms. In several areas, items were observed on windowsills, tabletops, counters, bookcases and desks. The large number of items stored in classrooms provides a source for dusts to accumulate (Picture 11). These items (e.g., papers, folders, boxes) make it difficult for custodial staff to clean. Dust can be irritating to the eyes, nose and respiratory tract. For this reason, items should be relocated and/or cleaned periodically to avoid excessive dust build up.

**Accumulated Dust and Cobwebs in Classroom**

10. Relocate or consider reducing the amount of materials stored in classrooms to allow for more thorough cleaning of classrooms. Clean items regularly with a wet cloth or sponge to prevent excessive dust build-up.
